USGS/TWRI Research Progress Report

POST-RESTORATION EVALUATION OF URBAN STREAMS IN CENTRAL TEXAS

Megan D. Meier and Anne Chin

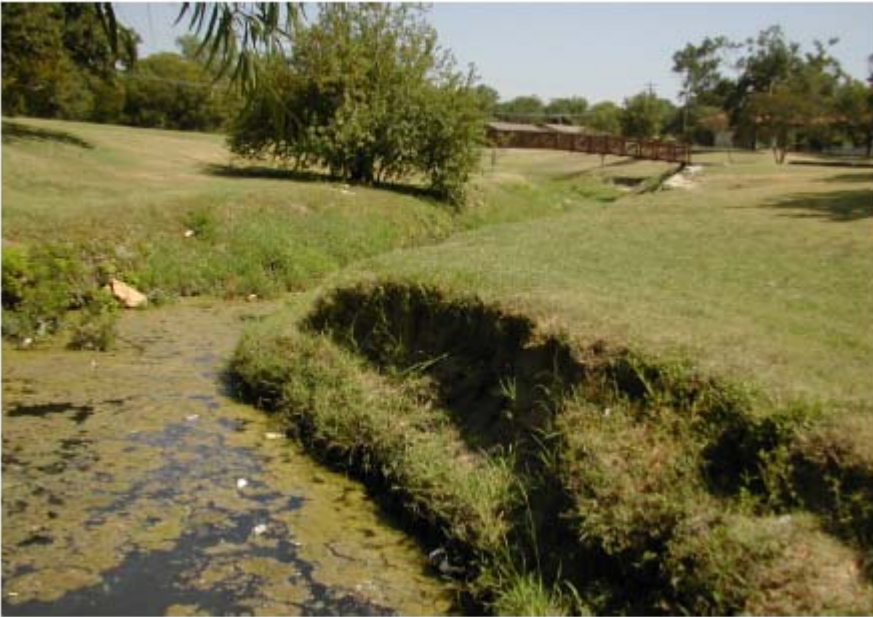
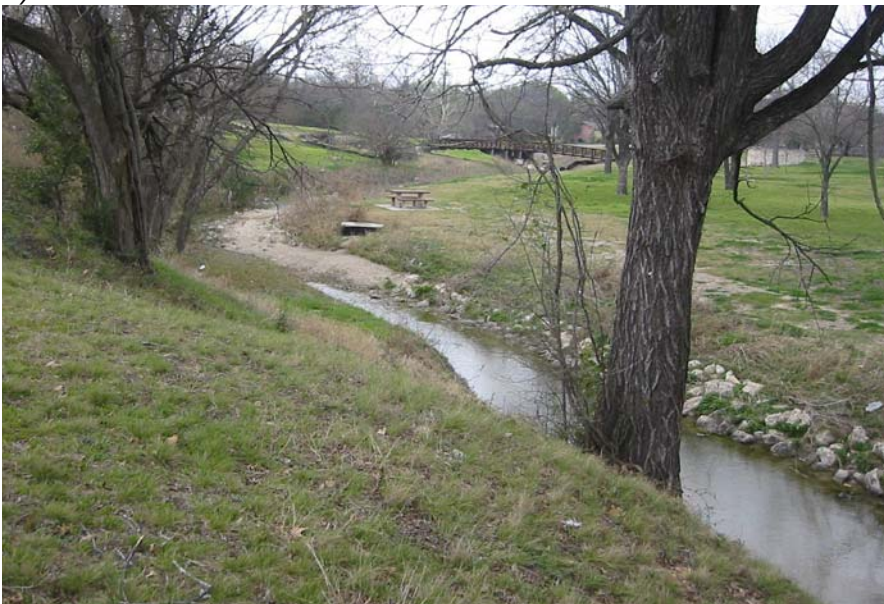
- The channel was reconstructed using rock to armor banks and to provide grade control within the channel. Native vegetation was also planted (Fig. 2)

Figure 2. Tannehill Branch Creek at Bartholomew Park a) before restoration in 2003 (M. Rotar) and b) after restoration in 2007.

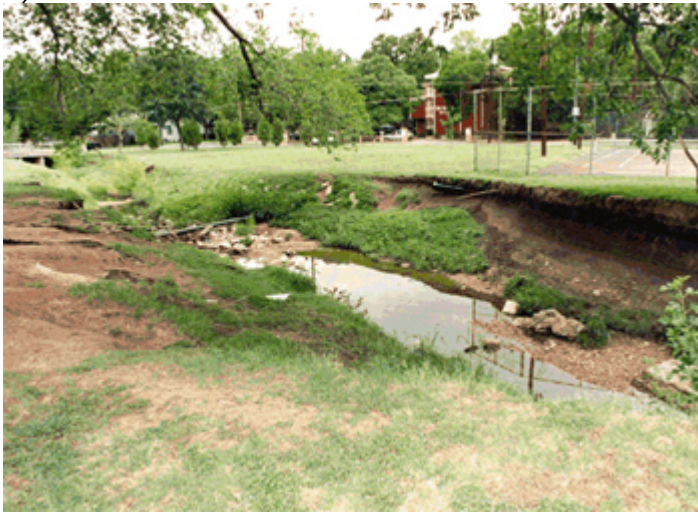
- This site is located within one of the most urbanized watersheds in Austin, containing the University of Texas and the State Capitol building (Fig. 1)
- Drainage area is approximately 16 km²
- Restoration of a 95 m reach was completed in 1998.
- Rock armor and native vegetation stabilized channel banks. A pool-riffle system was also constructed to protect the stream bed (Fig. 4).

Figure 4. Waller Creek at Shipe Park a) before restoration in 1997 (City of Austin, 2001b) and b) after restoration in 2007.
